Case 367 : Narrative

Case Vehicle (A): 2002 Dodge	Vehicle (B): 2002 Ford
Type: Dakota Sport, 4 x 2, 4-door pickup	Type: Explorer XLS, 4 x 4, 4-door SUV
Driver: 61-year-old male	Driver: 44-year-old female
CDC: 12-FYEW-4	CDC: 01-FDEW-3

CASE NO.: 367-03

CASE VEHICLE: 2002 Dodge

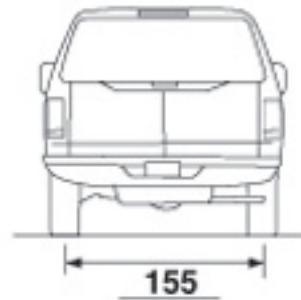
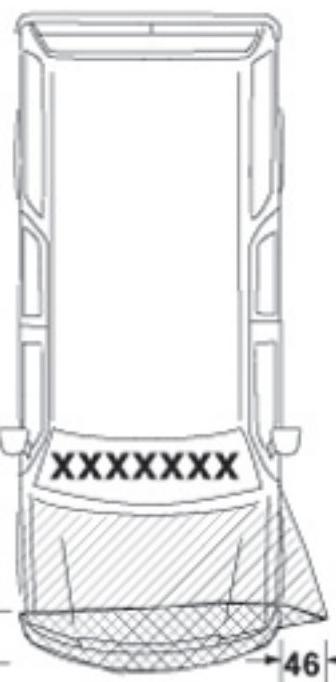
Max. crush to
center front—
bumper

63

Left fender
deflected to
left

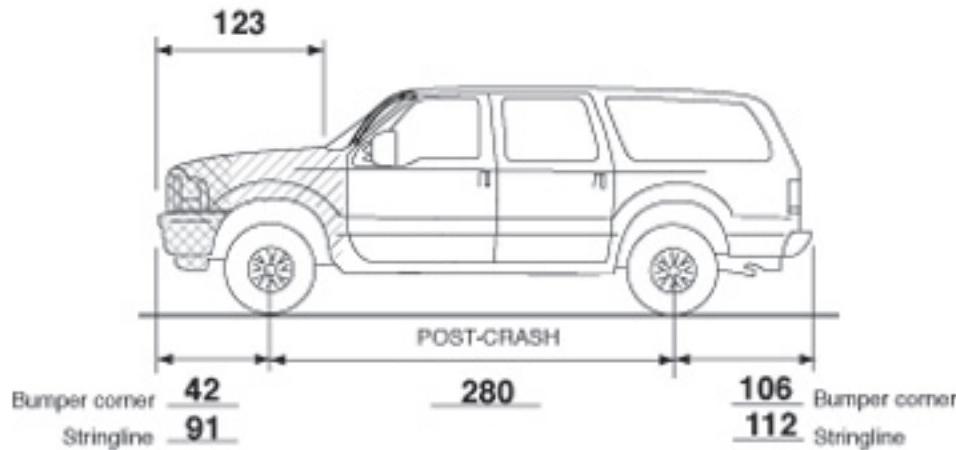
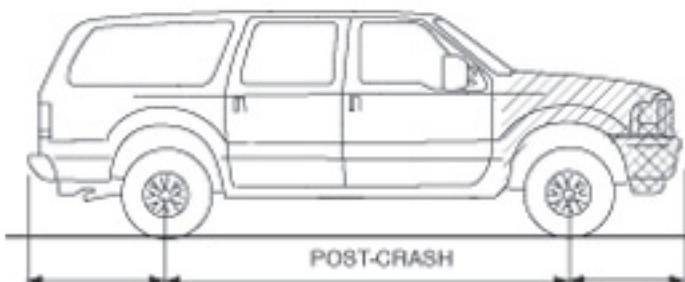
Bumper corner
Stringline

106
112

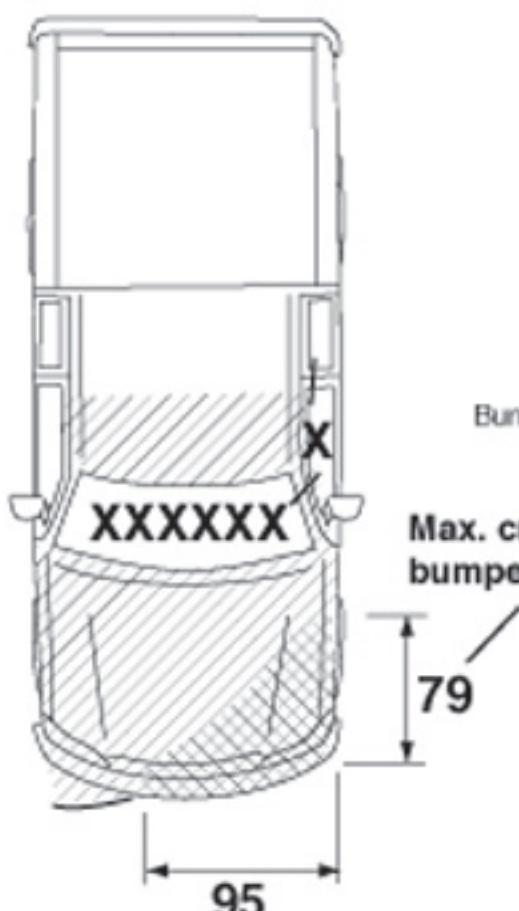
**Width of direct damage
to front**

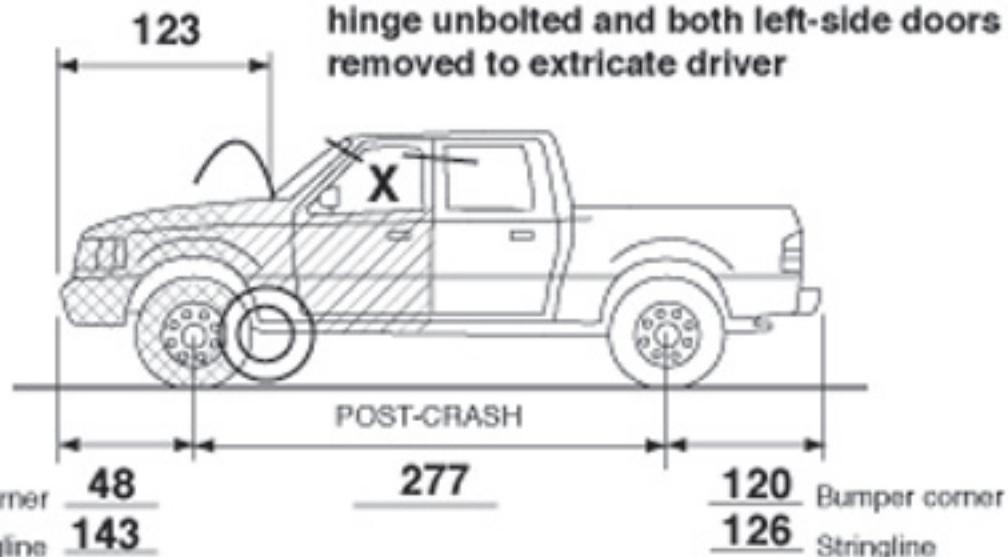
**Max. crush to left-front
bumper corner**

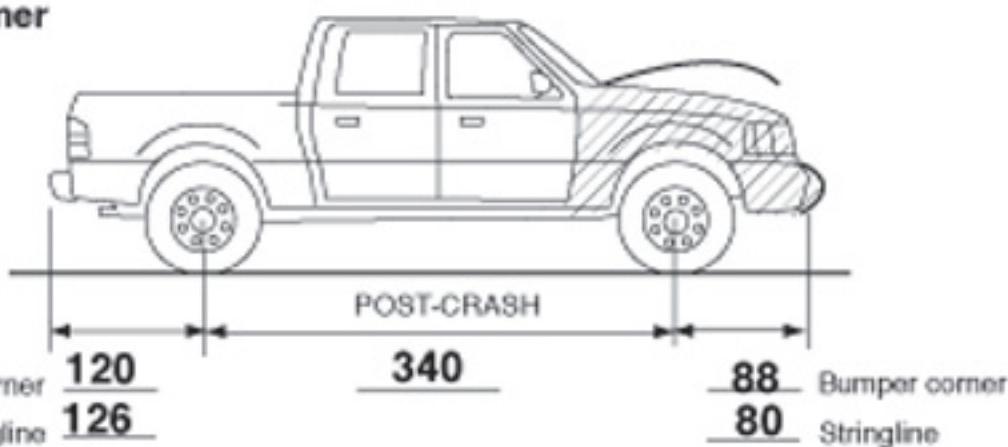
WINDSHIELD MARK ON CASE VEHICLE:

**Windshield cracked on left due to contact by rear hood edge
and on right due to body distortion**

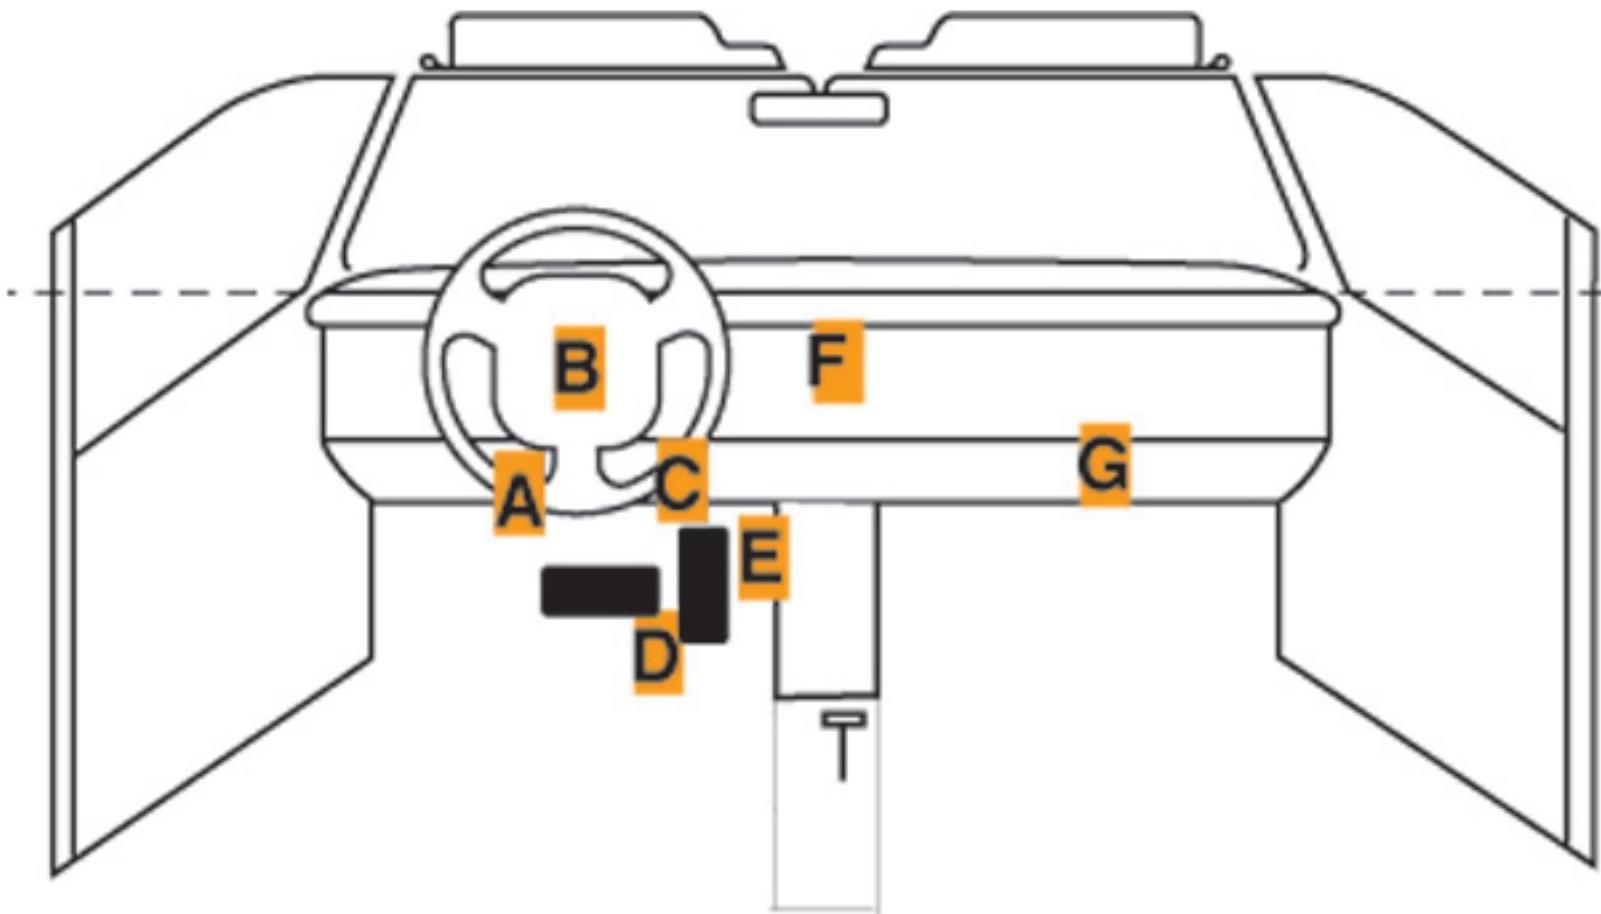
OCCUPANT CONTACT WORKSHEET

A = bottom half of steering wheel
rim, bent forward 9 cm

B = airbag, blood stains

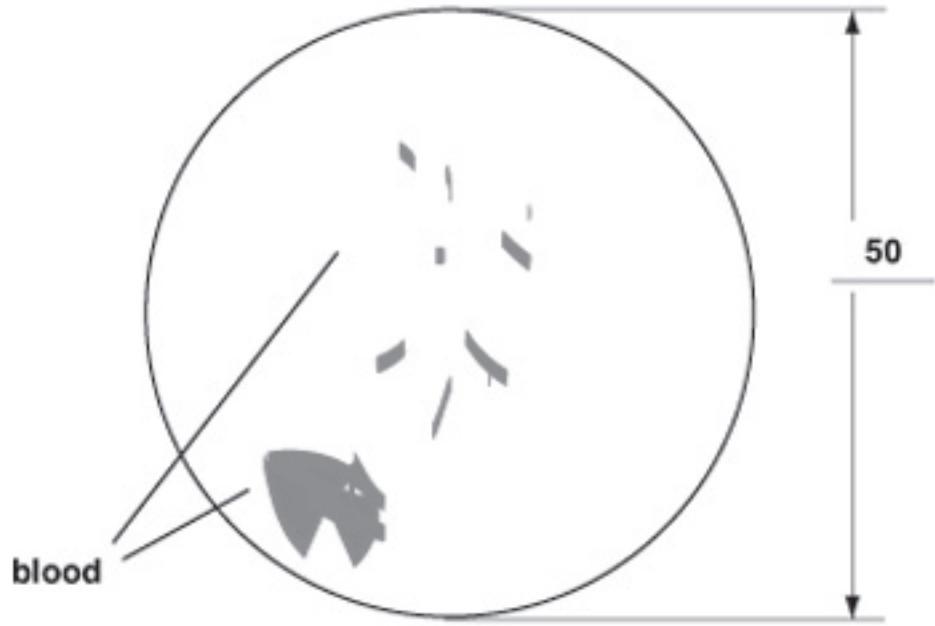
Driver Airbag Door

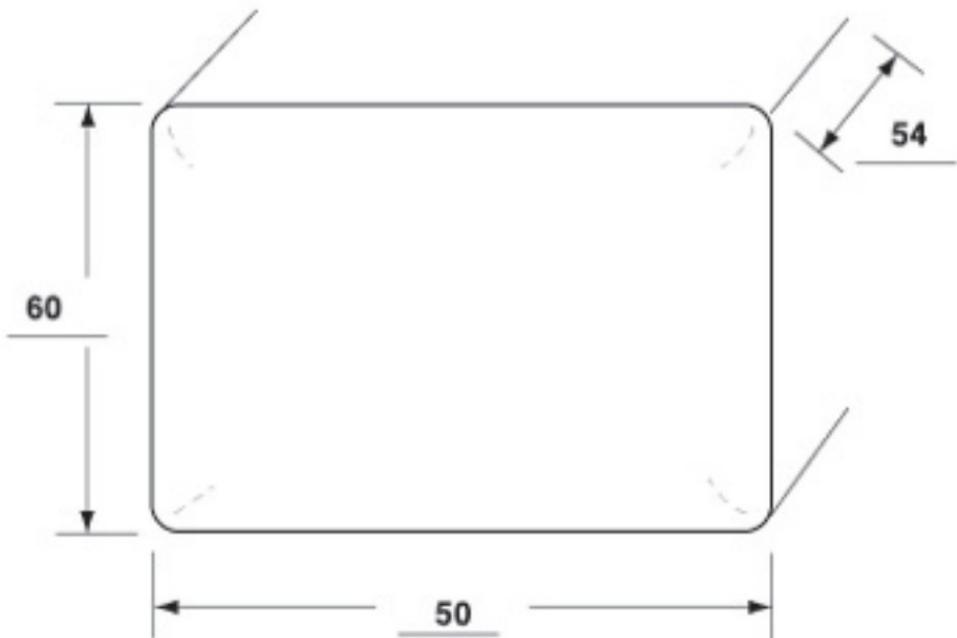
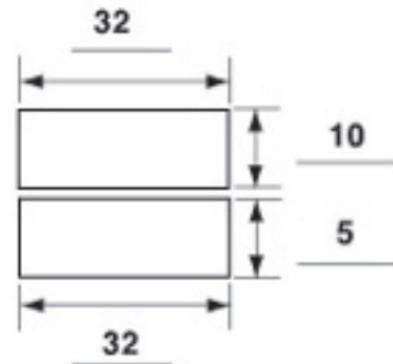
Passenger Airbag Door

Vents: Y N 2
if yes, how many: _____
3 and 9 o'clock on sides
